# **Exhibit H**

**SUBJECT:** Ice room or ice maker frozen or leaking, fan noise from ice room

SERVICE BULLETIN	
<b>Product:</b>	<b>French Door Refrigerators</b>
<b>Bulletin Date:</b>	<b>07/17/2015</b>
<b>Bulletin Number</b>	<b>ASC20150717001</b>
<b>Models:</b>	RF23HCEDB, RF23HCEDT, RF23HSESB, RF23HTEDB, RF23J9011, RF24FSEDB, RF25HMEDB, RF263BEAE, RF263TEAE, RF26J7500, RF28HDEDB, RF28HDEDT, RF28HFEDB, RF28HFEDT, RF28HFPDB, RF30HDEDT, RF31FMEDB, RF31FMESB, RF323TEDB, RF32FMQDB, RF34H9950, RF34H9960, ALL COLORS

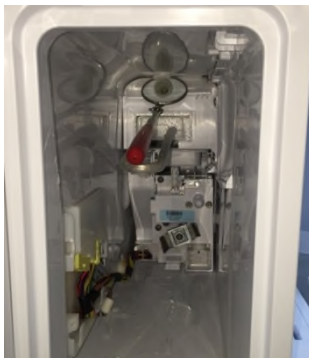
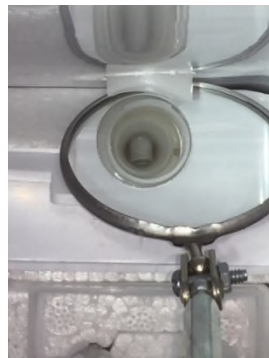
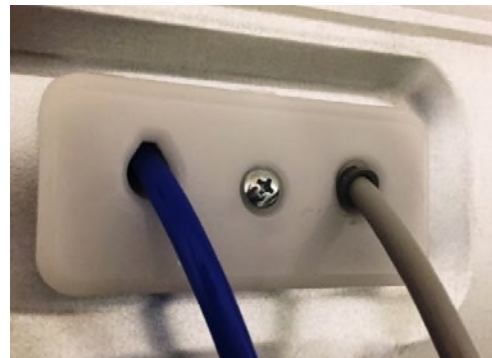
The water hose to the ice room fill tube is inserted too far into the fitting which causes water to splash out during the ice maker fill cycle. This water settles in the ice maker tray, causing condensation and frost.

- Remove the ice maker, and then check the fill opening using an inspection mirror (see pictures below).
- The fill tube may be inserted too far.
- If tube is inserted too far, the fill tube (grey) can be pulled back slightly.

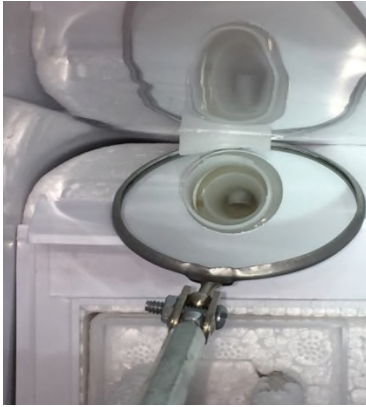
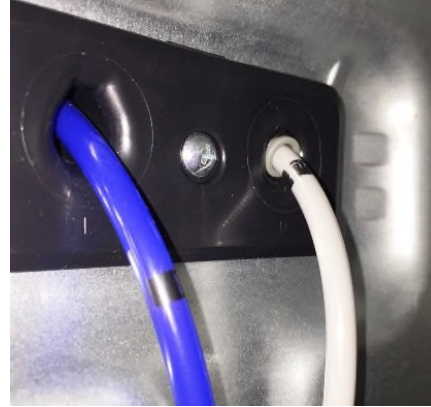
**Hose inserted correctly.**

- The picture below left shows the fill tube inserted properly in the fitting. Only a short length of the tube is visible inside the opening. A shorter amount of visible tubing is also correct.
- The picture on the right shows the black mark on the fill tube. **This mark can be used as a guide, but always inspect the tube from the inside to verify correct positioning. The mark should be completely visible.**

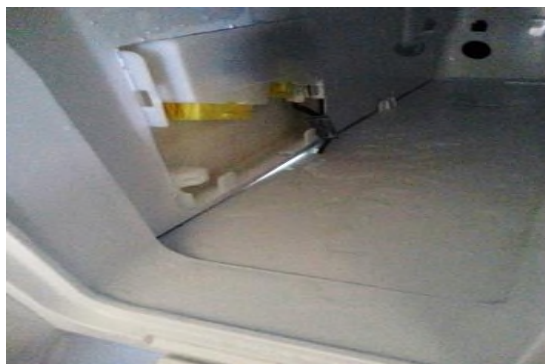
### **Abnormal Gap**

There is a gap between the liner and the floor of the ice room. The gap is due to variances in the surfaces. Warmer air from the FF section is drawn into the ice room, causing condensation and slushy ice.

- Remove the ice maker and the auger motor assembly following the correct procedures.
- Apply a bead of RTV Epoxy to the seam **from back to front** (see illustration below).
- Best results are achieved when the ice room is dry and warm, but do not use a heat gun or hair dryer to assist.

**Part number: DA81-05595A A/S Epoxy**

**Note:** Shine a light from the bottom of the ice room to see the gap. If all you see is a dim light, that is not a gap, it is light passing through the foam seal. This is normal and no epoxy is needed. Check for other causes.

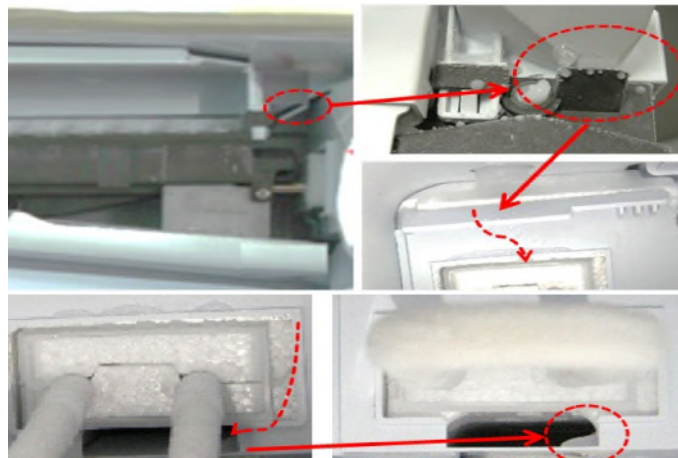
- Ice forms in the ice room fan air duct, causing fan noise and icing up. This is caused by water running down the air duct cover and puddling in the duct. The water freezes and builds up over time.

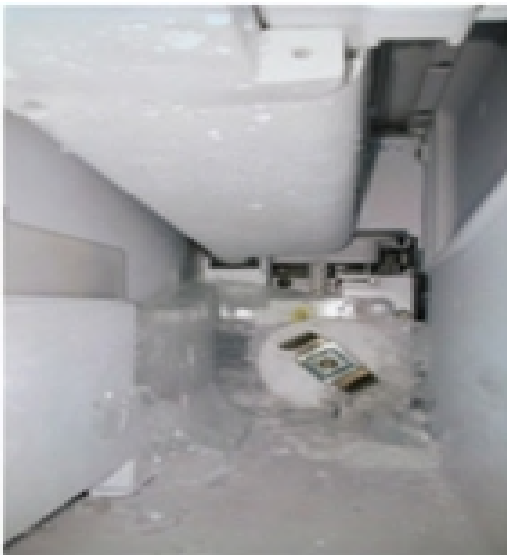
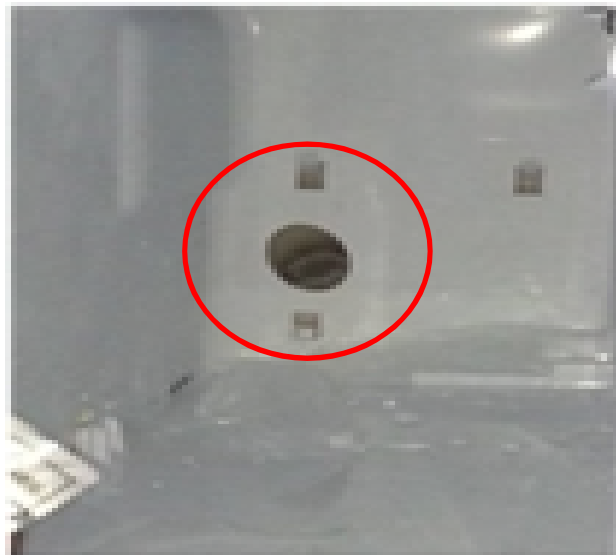
The drain tube that runs from the ice room to the drain pan is frozen or clogged. Water backs up into the ice room and freezes. The ice bucket becomes stuck or the system will not dispense properly.

- Use a steamer to defrost the ice buildup. This may take some time depending on the amount of ice.
- Remove the ice maker and auger motor, and then use a steamer to defrost the frozen drain.
